OLD MORRIS CANAL DAM NJ 00173

PHASE 1 INSPECTION REPORT NATIONAL DAM SAFETY PROGRAM.

Old Morris Canal Dam (NJ-00173).
Passaic River Basin. Rockaway River,
Morris County, New Jersey.

Name of Dam:	Old Morris Canal Dam
ID Number:	ID No. NJ00173
State Located:	New Jersey
County Located:	Morris
Stream:	Rockaway River
River Basin:	Passaic
Date of Inspection:	May 14, 1979

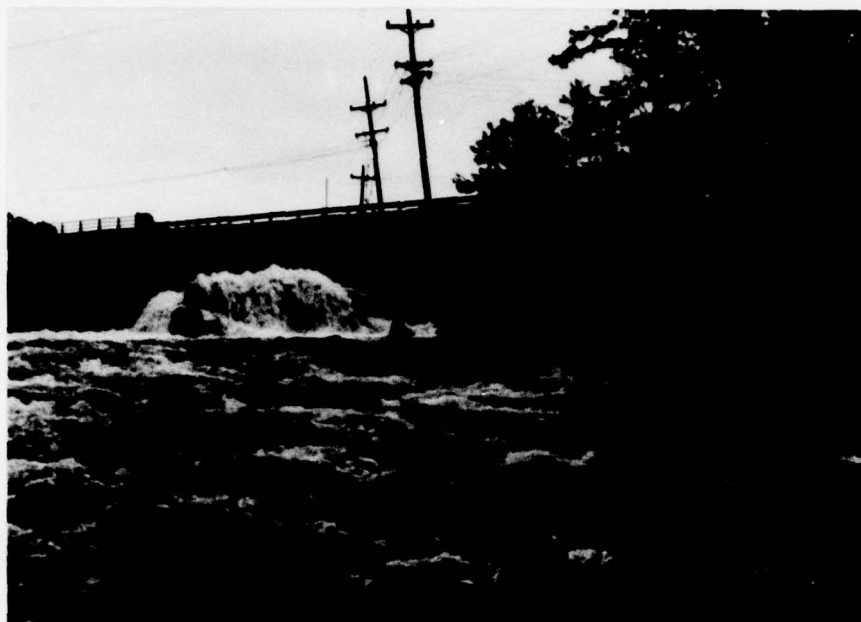
VIEW OF NORTHEAST SIDE OF SPILLWAY FROM DOWNSTREAM

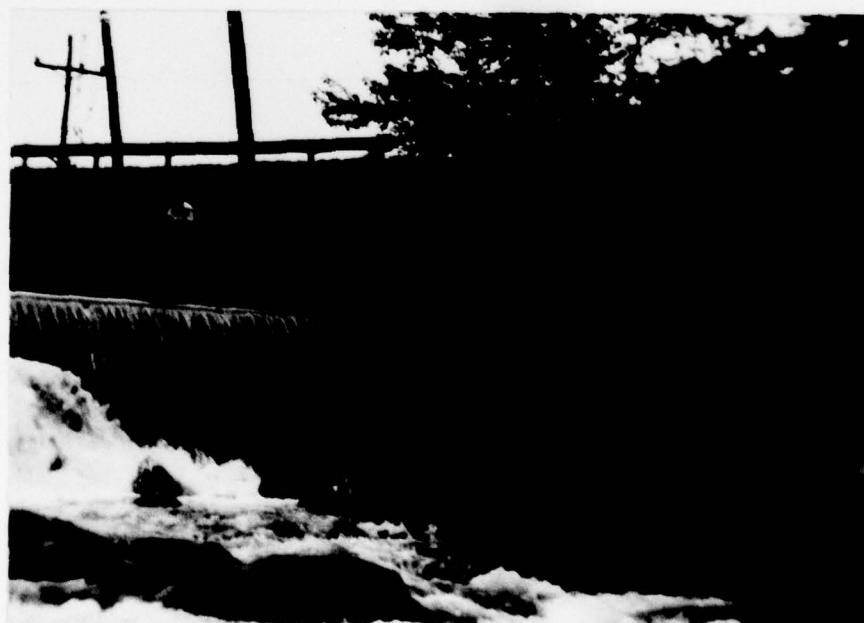
e. Downstream Channel. The bottom of the downstream channel appears to be bedrock covered with large boulders. On the northeast bank of the channel is a dry stone masonry training wall which has raveled and collapsed. A large washout of the fill placed in the former canal was observed on the northeast bank immediately downstream of the end of the overflow section of the dam. Large boulders have been dumped into the washout area. The washout does not appear to be the result of river water action. Trees overhang the downstream channel. The channel itself is wide and unobstructed.

DOWNSTREAM SIDE OF NORTHEAST ABUTMENT

a. Within 30 days from the date of approval of this report, engineering studies and analyses should be initiated to design and supervise repairs to the undermining and serious erosion at and below the northeast abutment.

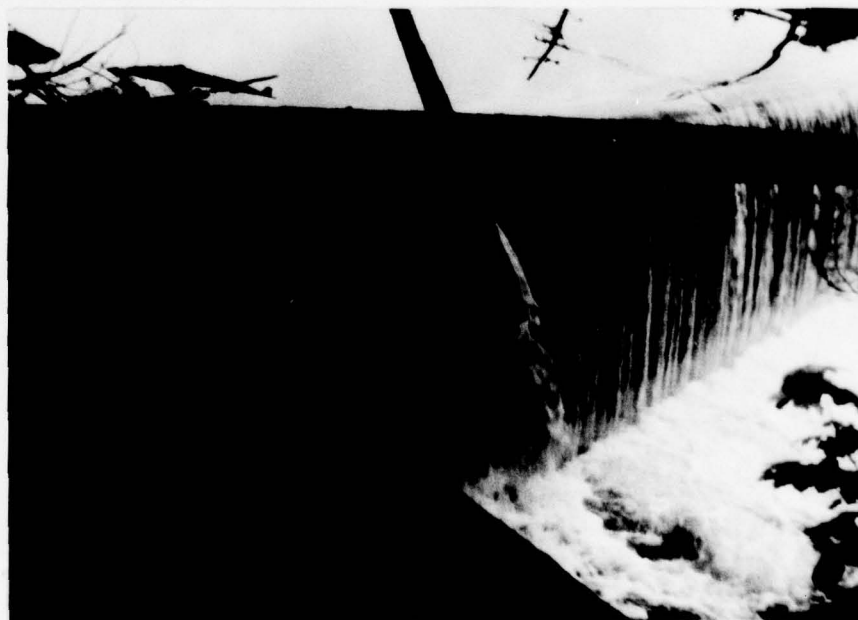
b. Dam. Water was discharging over the overflow section of the dam at the time of the inspection, and it was consequently not possible to determine visually the character and condition of that section. Based on what could be seen beneath the overflowing water close to the abutments, it appears that the overflow section is a stone masonry dam with a concrete cap and upstream facing. The concrete cap near the abutments appears to be in fair condition. It shows evidence of limited erosion and some coarse aggregate is visible. The crest of the overflow section is very straight along each of the two sections of the dogleg alignment. There is a bedrock knob exposed on the downstream face at the break in alignment of the crest and bedrock is also exposed on both sides of the channel downstream of the dam. It appears, therefore, that the overflow section is founded on bedrock. There is a concrete training wall at each end of the overflow section. The surface of both training walls is badly spalled and eroded, particularly at the water surface. Between the northeast end of the dam and the northeast abutment (which is a highway fill) there is a fill which extends upstream and downstream with an essentially horizontal surface. This fill is used as parkland. A large timber, a large log and several other pieces of debris are lodged on the crest of dam near the southwest concrete training wall.

DEBRIS ON TOP OF SOUTHWEST ABUTMENT

b. Within 30 days from the date of approval of this report, the debris lodged on the southwest end of the spillway crest should be removed.
